Convention Center Built on Reclaimed Riverbed Suffers from Settling, Erosion, and Construction Issues. Contractor Uses **TerraThane™** to Fill Voids, and Raise and Level Concrete Slabs.

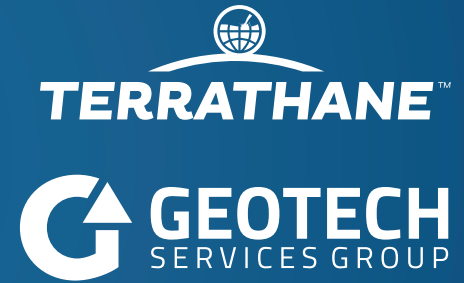
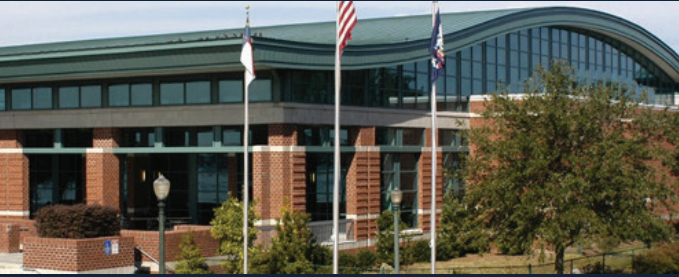
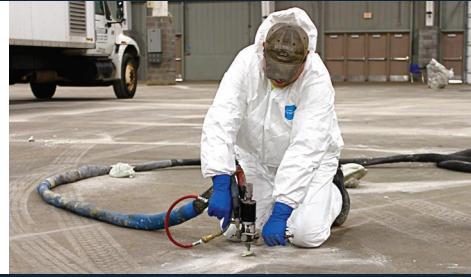
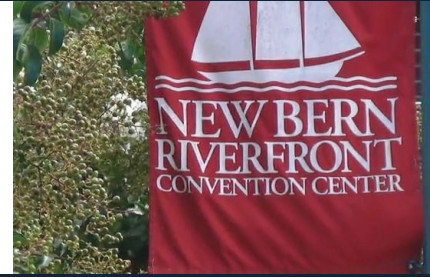
12-year-old riverfront Convention Center in New Bern, NC, was in trouble. The building's exterior is supported by pilings driven deep into the ground, but the floors sit directly on the earth and silt of the old riverbed. The land was in-filled by old docks and building debris in the 1970s and settling, erosion, and construction issues were taking their toll on the building:

- + Parts of the floor and patio sunk up to seven inches
- + Cracks and uneven joints in the concrete slab floors were causing walking/tripping hazards
- + Gaps beneath walls were allowing sound to pass between what were designed as sound proof rooms

Contractor Hayward Baker drilled multiple 5/8-inch holes in a 5 ft. x 5 ft. grid and pumped in over 10,000 lbs. of TerraThane™ geotechnical polyurethane foam to fill the voids beneath and raise the concrete slabs to their original position. Terry Phillips, superintendant with Hayward Baker says, "TerraThane is the way to go. It's clean—there's really no mess—it's much quicker than traditional products, strong, and lasts the life of the building."
