# Pepsi Bottling Plant in Nashville, TN Uses TerraThane™ by NCFI to Save Spillage and Lost Product

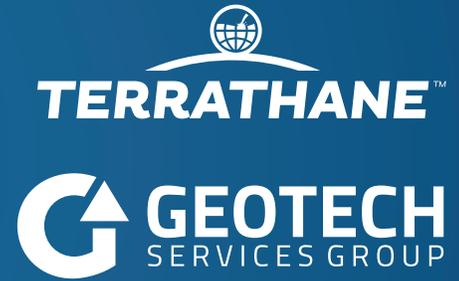
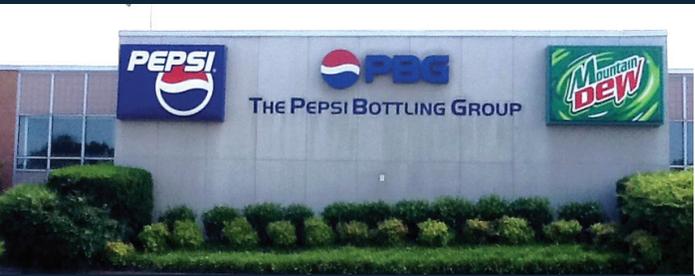
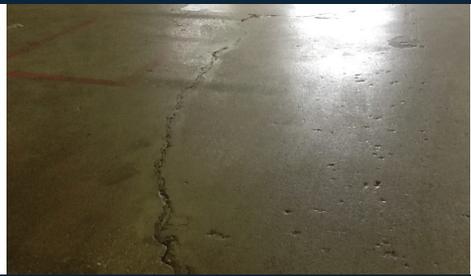
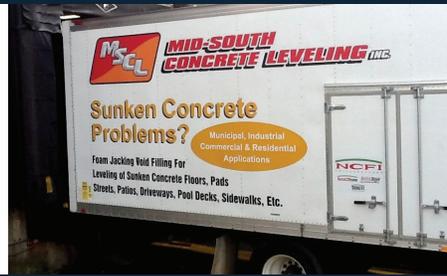
Erosion beneath warehouse's concrete slab floor causes uneven joints and rocking slabs. Forklift drivers experience jolts, and bumps, and lose product, which in turn costs the company money.

Concrete floors are cut into smaller slabs not long after the concrete is poured and the cuts create control joints that separate a large concrete floor into smaller squares. Over time the earth beneath the concrete slabs erodes, voids form, and the slabs become uneven. Heavy machinery, like forklift traffic, traveling over the unsupported slabs can cause them to rock up and down, jarring the forklift, discomforting the driver, and costing the plant money in ruined product. Eventually breaks or fractures called "joint spalling" occur and it gets even more costly. Left unchecked spalling can spread and ruin the entire slab.

Bolton applied a new technology solution: TerraThane™ Geotechnical Polyurethane Foam. "Geotech polyurethane foam provides a low-impact and reliable means for stabilizing concrete joints," says Bolton, who has been using the TerraThane™ for over a year. "We cleaned out all the joints, removed the debris, drilled 5/8-inch holes about every three-to-four feet, and pumped in TerraThane™ void fill foam to fill the joints. It worked great, and quickly so no real downtime for the warehouse."

"Pepsi was so pleased they asked us to patch about 130 feet of cracks in the slabs. The floor was ready to use by the time we left the plant. We're already getting more work from Pepsi." Bolton says his company chose TerraThane™ because it's faster, requires less set-up time (generally reaches ninety percent strength within 15 minutes of injection), requires very little clean-up after the work is complete, and
